**INITIAL GEOLOGIC AND
GEOTECHNICAL EVALUATION
ARIZONA EASTERN RAILWAY
GRAHAM COUNTY, ARIZONA**

October 20, 2006
Project No. 601605001

Subject: Initial Geologic and Geotechnical Evaluation
Arizona Eastern Railway
Graham County, Arizona

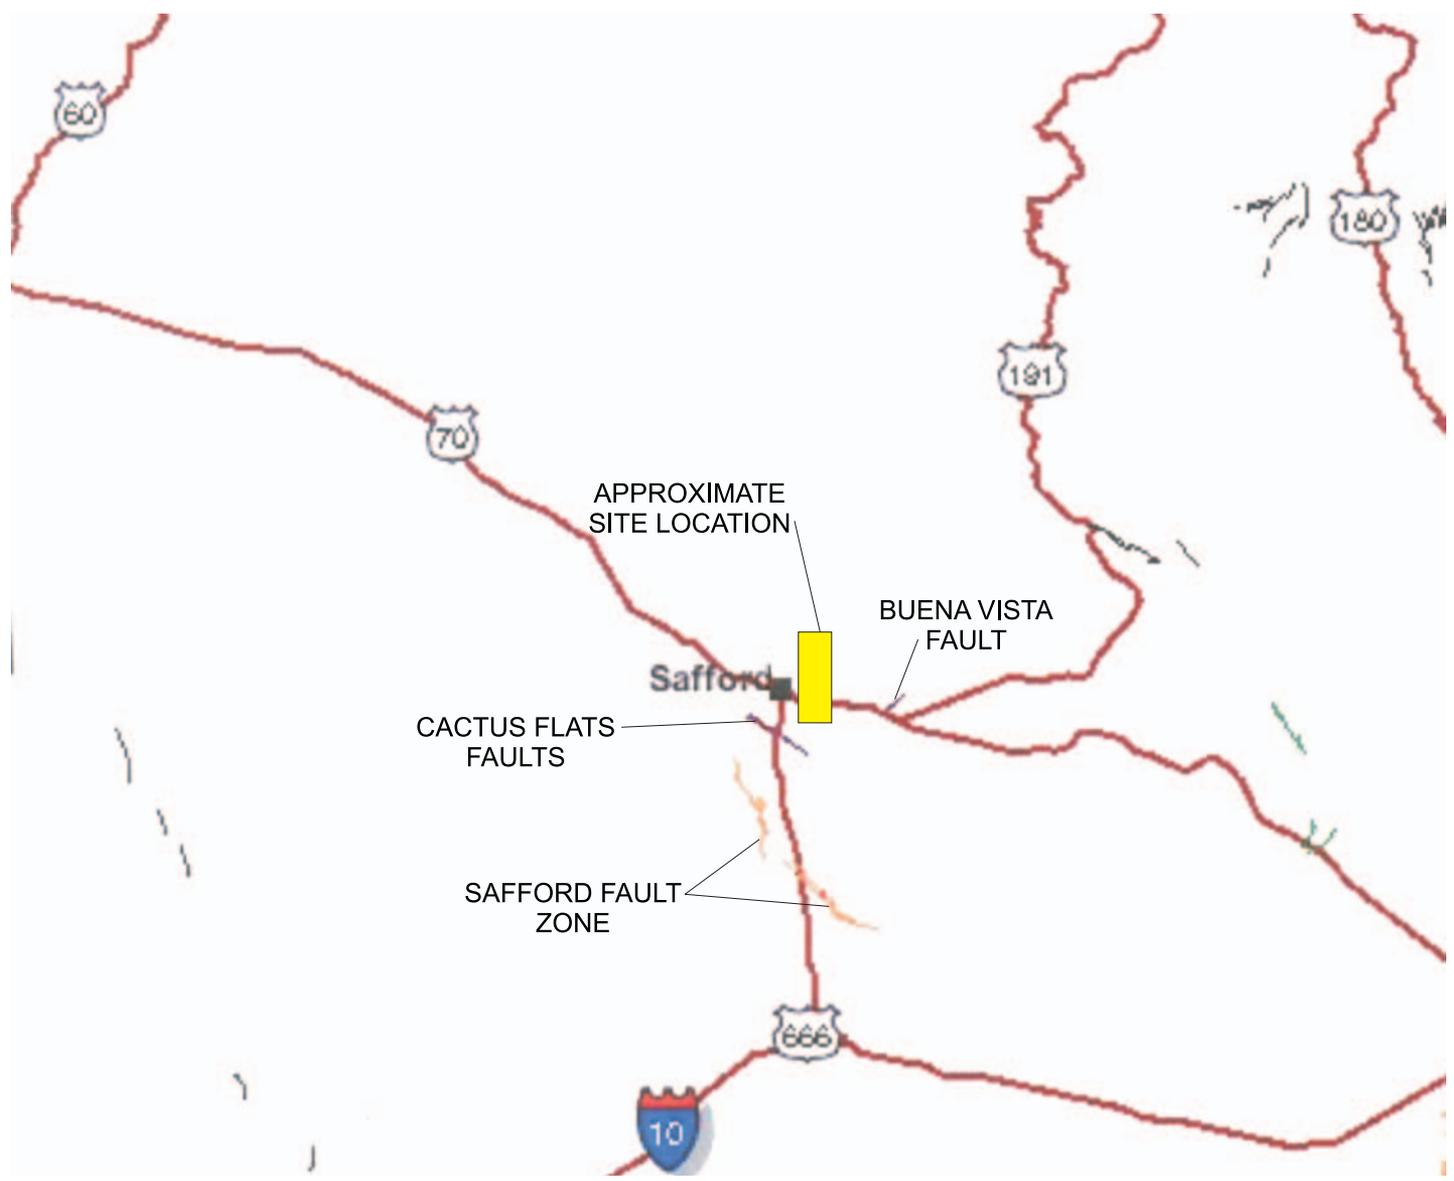
Ninyo & Moore		QUATERNARY FAULT MAP	FIGURE
PROJECT NO: 601605001	DATE: 10/06	ARIZONA EASTERN RAILWAY GRAHAM COUNTY, ARIZONA	5

SOURCE: USGS EHP QUATERNARY FAULT AND FOLD DATABASE.
