Federal Railroad Administration

Pursuant to the Memorandum of Understanding Between the Surface Transportation Board (STB) and the Federal Railroad Administration (FRA) dated May 19, 1998, FRA is forwarding its second biannual status report to the STB covering the safety integration of the Conrail merger (enclosed).

This report, dated June 23, 2000, covers the period of FRA's surveillance of safety integration from May through December 1999. In this second reporting period, formal review meetings have been held by FRA with CSX Transportation (CSXT), Norfolk Southern (NS) and the new Conrail (CRCX, the new AAR reporting designation for the Shared Assets Areas) at approximate bi-monthly intervals. As of December 1999 most of the Safety Integration Plan (SIP) items, as defined in their acquisition filings, had either been closed out or continuing programs (e.g., training) had been put in place to address them. SIP/safety reviews were held in June, July, August, October and December 1999.

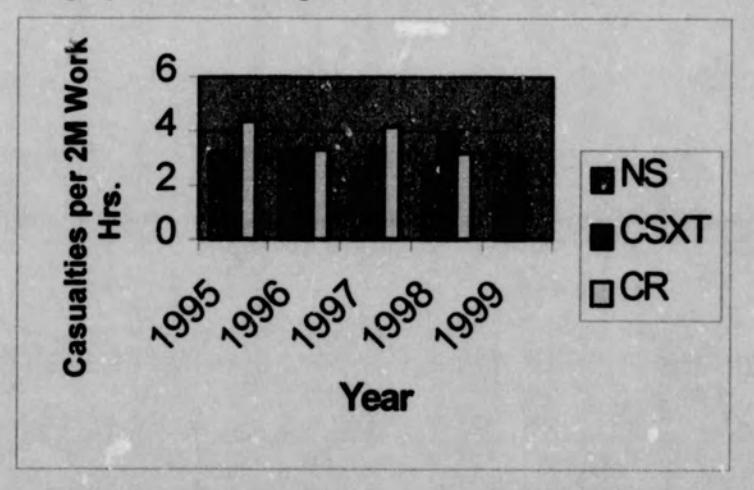
Figure 5: Employee Casualties per Two Million Hours Worked 1995-1999

Note: Data for Conrail in each of the preceding figures are for the former Conrail. 1999 numbers for CSX and NS include the portions of Conrail that each railroad now operates. 1999 data are for Jan. – Nov. (11 months) only.

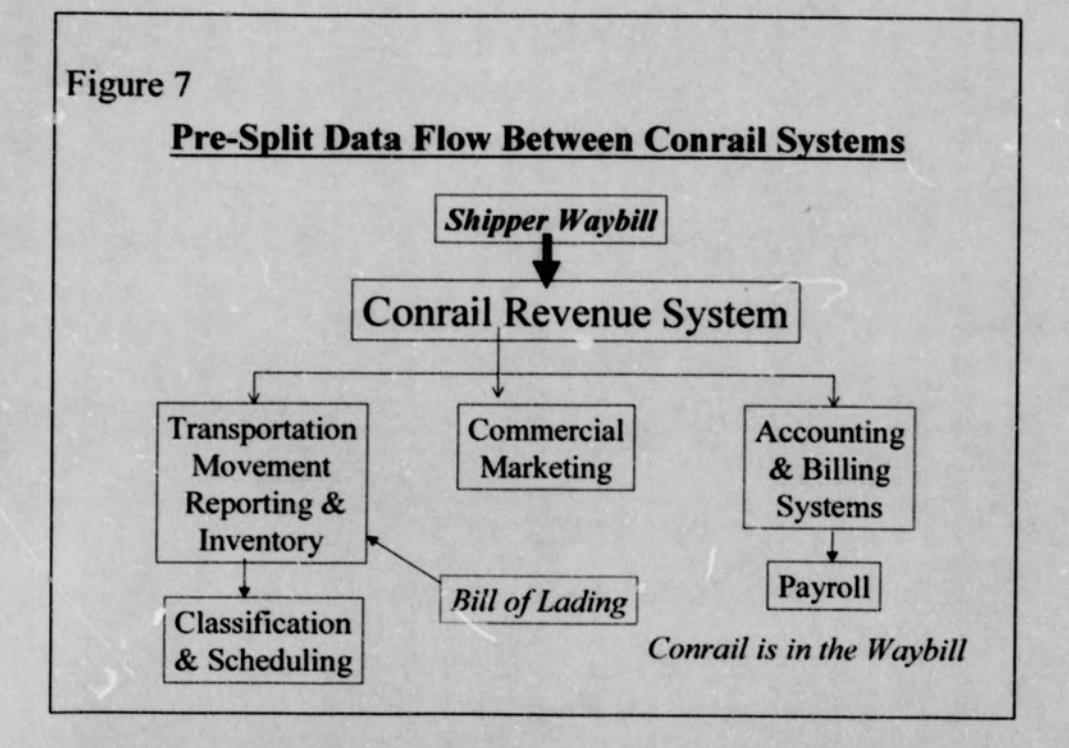
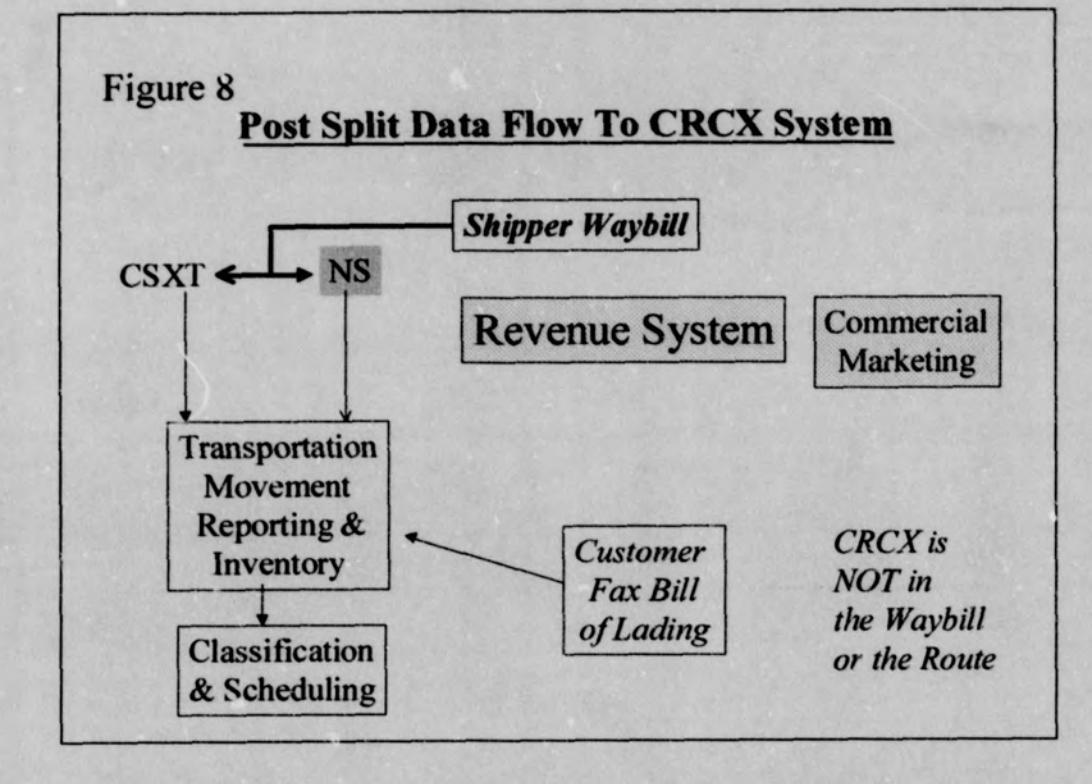
Figures 7 and 8 (pages 61 -- 62) are simplified "before and after" representations of how data was and is now transmitted to the CRCX TRIMS system. On page 61, figure 7 shows how all transportation movements were directly linked to the waybill in the May 1999 pre-split situation. On pg. 62, figure 8 shows how, absent reliable information transfer from CSXT and NS, the CRCX managers are now dependent on fax bill of lading messages as a backup process.

As a result of this approach to systems integration, the pre-existing 99.7 % accurate Conrail hazardous materialss management control process began to fail immediately following the June 1 integration. As the examples in this paper show, seven months into the acquisition FRA inspectors are still finding serious documentation problems. The errors continue despite more than 700 IT projects undertaken by all three railroads prior to Split-Date, and the continued use post split of CSXT and NS established "SWAT Teams" to attack identified IT related problems since June, as well as numerous meetings between FRA and the three railroads.

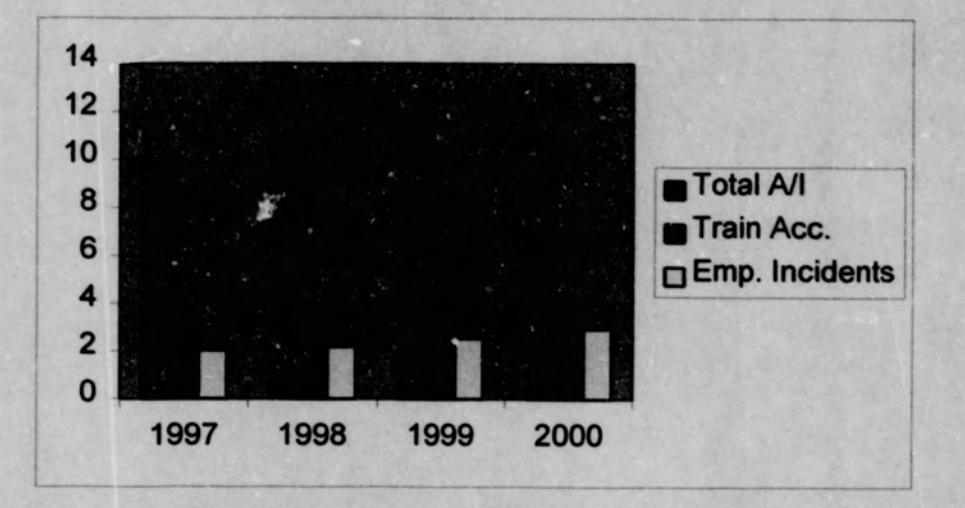
Figure 2: CSXT Safety Performance 1997 – 1999 (January to June each year)

Figures 2 and 3 on page 10 show safety performance for CSXT and NS for 1997 through 2000, during the first half year in each year. Note that, while total accidents/incidents for the first quarter of 2000 are down, "employee on-duty incidents" have increased for both railroads.

Note: Train accidents per 1,000,000 train miles Employee incidents per 200,000 hours worked

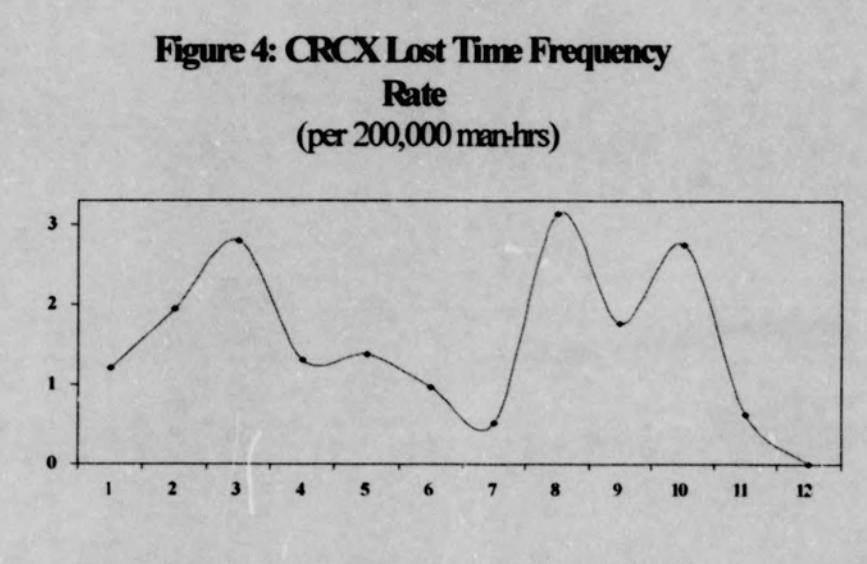
Figure 4 graphically illustrates the lost time frequency rate on a year to date basis for the shared asset operation of CRCX, and Figure 5 indicates the safety performance change on a year to date basis for 2000 versus 1999, for the CRCX corporation as a whole and for each of its three operational regions. The regions include Northern New Jersey (NNJ), Southern Jersey and Philadelphia (SNJ) and the Detroit area. Only the South Jersey area had a negative change. The positive improvement in North Jersey was 75%.

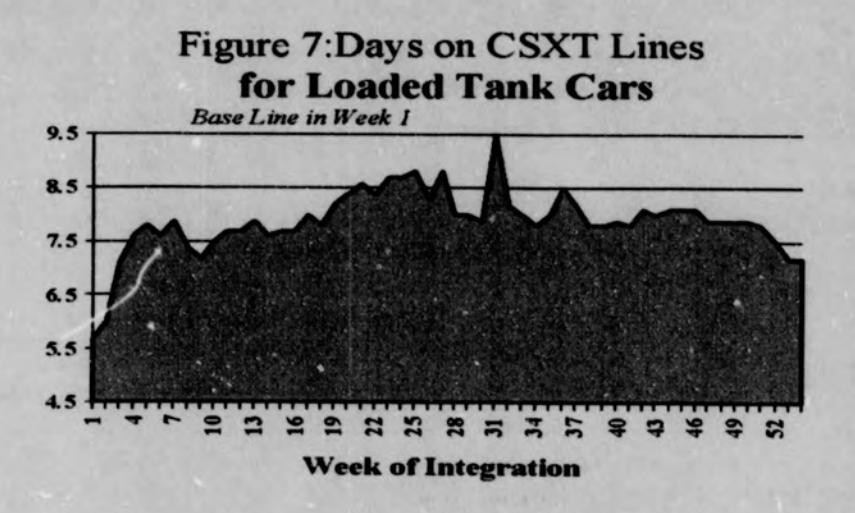
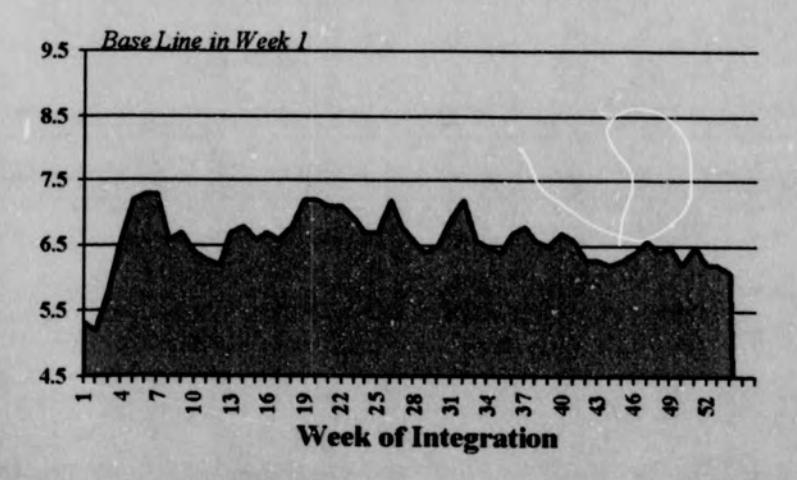
As of June 1<sup>st</sup>, the average days on line for tank cars (half of which 50% contain hazardous materials) on NS remains at 6 days versus 5.5 in June of 1999 (figure 7). On CSXT, average days on line for tank cars remains above 7 days versus approximately 5.6 in June of 1999 (figure 8).
